SAFETY CAMPAIGN

2020

IMPA Safety Survey 2020

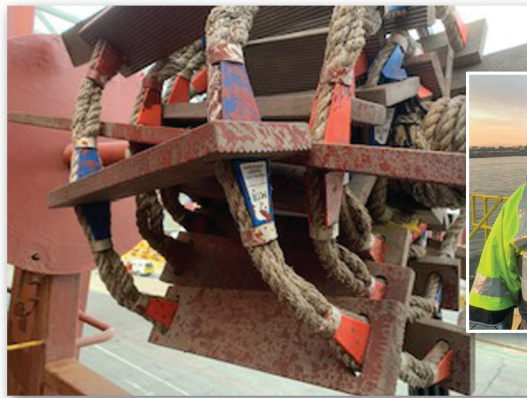
Ladder liberally splattered with 'red lead' paint which should have immediately condemned it.
