# SAFETY CAMPAIGN

2023

2023 has been an important year for the safety of pilot transfer arrangements. The International Maritime Organization (IMO) is working now to amend SOLAS regulation V/23 and its associated recommendations. This work is anticipated to result in an enhanced and more robust safety regime for pilot transfer arrangements for the benefit of pilots and other users.

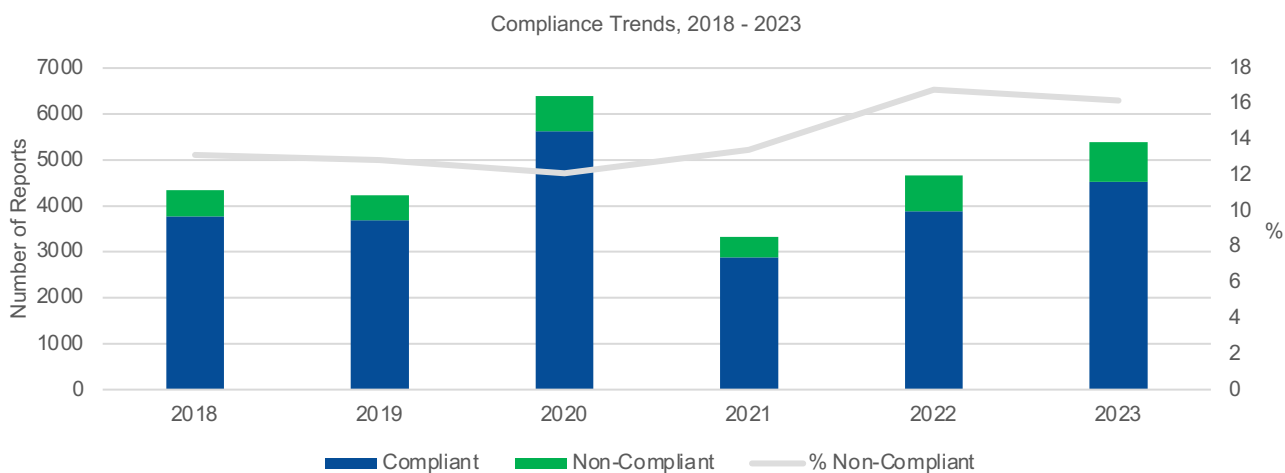
Figure 1: Compliance Trends, 2018 - 2023

The results of the 2023 Safety Campaign show that historical trends in non-compliance continue. The headline non-compliance rate remains over sixteen percent, and the main determinant of non-compliance remains pilot ladders. Pilot ladder observations are included in more than fifty percent of reports of non-compliant arrangements. These trends are highlighted in Figure 1.

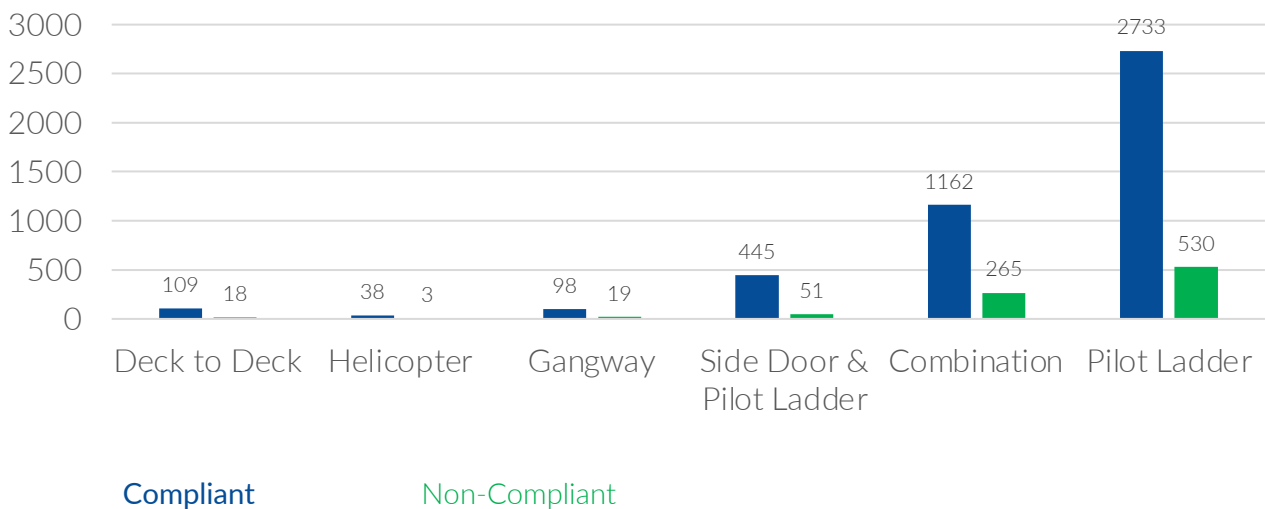
Compliant and Non-Compliant by Transfer Arrangement

Compliance by Means of Transfer	Total Number	Compliant	Non-Compliant	Non-Compliant as %
Pilot Ladder	3275	2733	530	16.18
Combination	1428	1162	265	18.56
Side Door & Pilot Ladder	498	445	51	10.24
Gangway	119	98	19	15.97
Helicopter	41	38	3	7.32
Deck to Deck	127	109	18	14.17

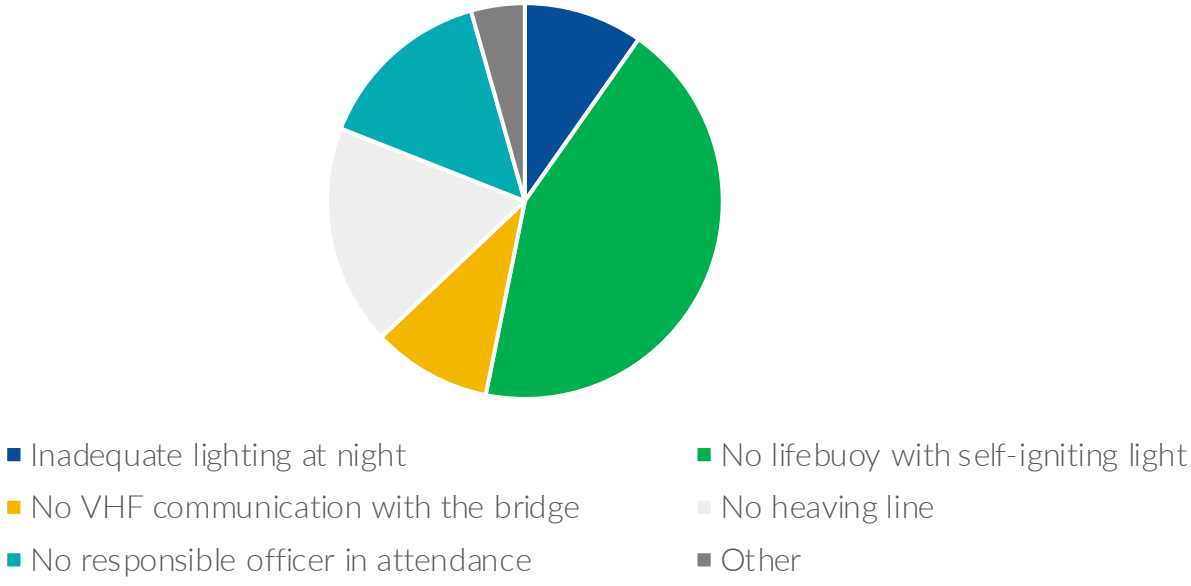
Safety Equipment Defects	Total	As %
Inadequate lighting at night	20	9.76
No lifebuoy with self-igniting light	89	43.41
No VHF communication with the bridge	20	9.76
No heaving line	37	18.05
No responsible officer in attendance	30	14.63
Other	9	4.39
