SAFETY CAMPAIGN

2016

IMPA held its annual Pilot Ladder Safety Survey this year from 1st to 14th October 2016. The purpose of the survey is to monitor compliance levels and draw to the industry's attention the defects that pilots encounter when boarding and disembarking vessels.

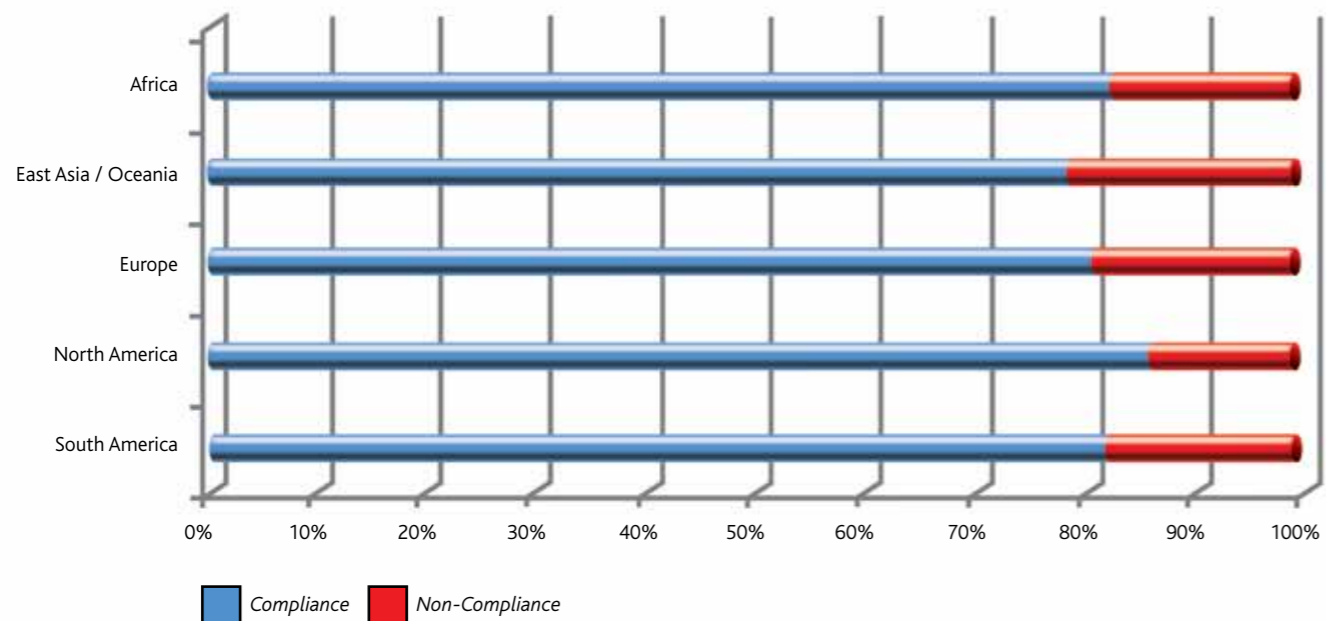
COMPLIANCE BY REGION

The charts below show 2,709 returns from participating IMPA members which have been grouped into 5 geographical areas. The total noncompliance is shown as a percentage of total returns from each region and as a total.

COUNTRY	TOTAL RETURNS	COMPLIANCE	NON COMPLIANCE	NON COMPLIANCE AS %
Africa	25	21	4	16.00
East Asia / Oceania	420	335	85	20.24
Europe	1636	1343	293	17.91
North America	127	111	16	12.60
South America	501	418	83	16.57
TOTAL	2709	2228	481	17.76

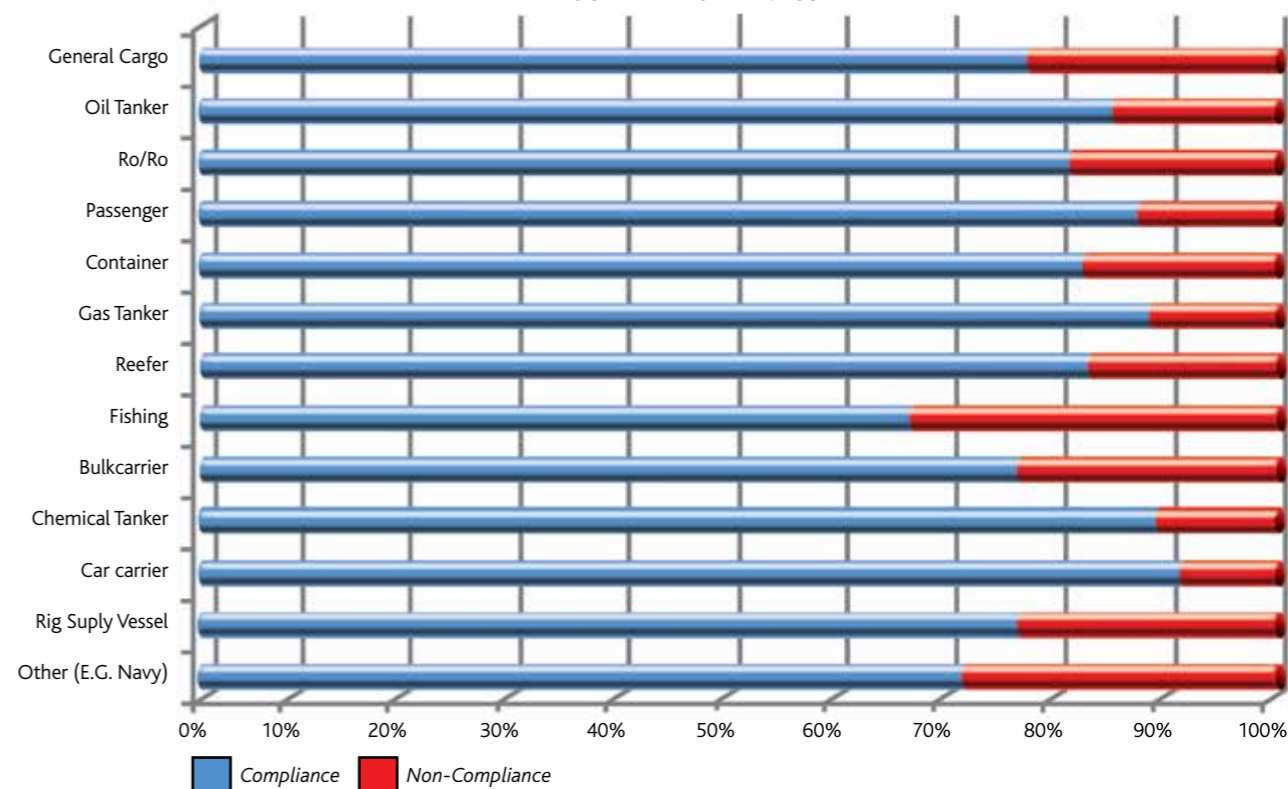
COMPLIANCE BY VESSEL TYPE

The following chart shows a break down of all returns by vessel type. Both the number and the percentage of noncompliant vessels by type are shown.

VESSEL TYPE	TOTAL NUMBER OF VESSELS	COMPLIANCE	NON COMPLIANCE	NON COMPLIANCE AS %
General Cargo	532	415	117	21.99
Oil Tanker	326	279	47	14.42
Ro/Ro	142	116	26	18.31
Passenger	216	190	26	12.04
Container	682	565	117	17.16
Gas Tanker	81	72	9	11.11
Reefer	24	20	4	16.67
Fishing	9	6	3	33.33
Bulkcarrier	328	252	76	23.17
Chemical Tanker	182	163	19	10.44
Car Carrier	85	78	7	8.24
Rig Supply Vessel	91	70	21	23.08
Other (E.G. Navy)	103	74	29	28.16

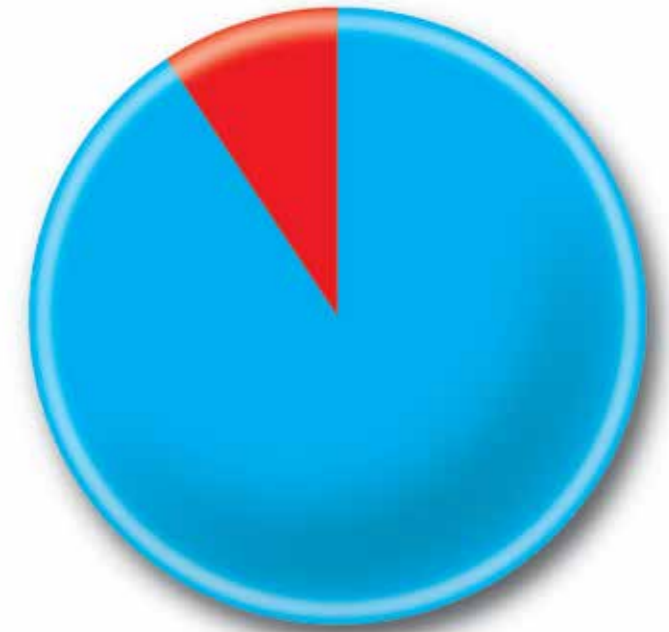
DEFECTS REPORTED TO AUTHORITY

TOTAL NUMBER OF NON-COMPLIANT SHIPS	481
Number of defects reported to Authority	50
% of non-compliant ships reported	10.4

Total number of non-compliant ships in survey reported ■
 Number of defects reported to Authority ■

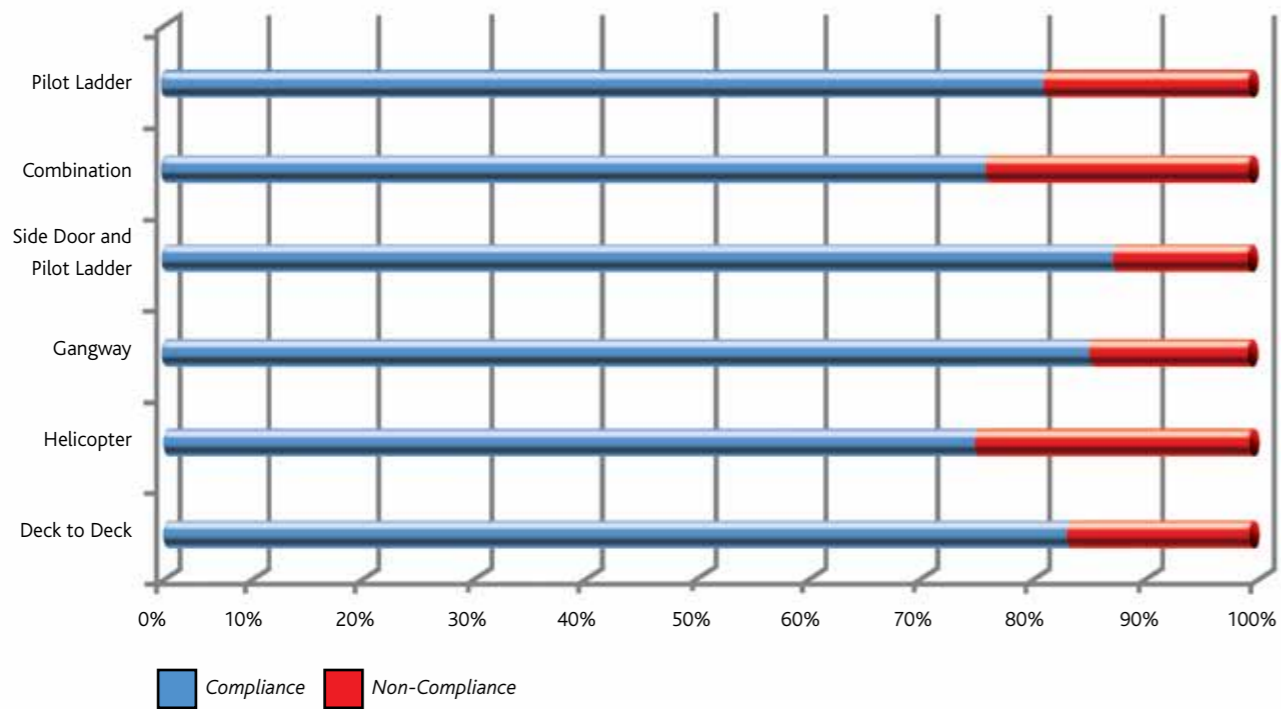
COMPLIANCE BY MEANS OF TRANSFER

The following chart shows a breakdown of all returns by means of transfer.

MEANS OF TRANSFER	TOTAL NUMBER	COMPLIANCE	NON COMPLIANCE	NON COMPLIANCE AS %
Pilot Ladder	1832	1511	321	17.52
Combination	429	329	100	23.31
Side Door and Pilot Ladder	295	260	35	11.86
Gangway	65	56	9	13.85
Helicopter	58	44	14	24.14
Deck to Deck	120	101	19	15.83

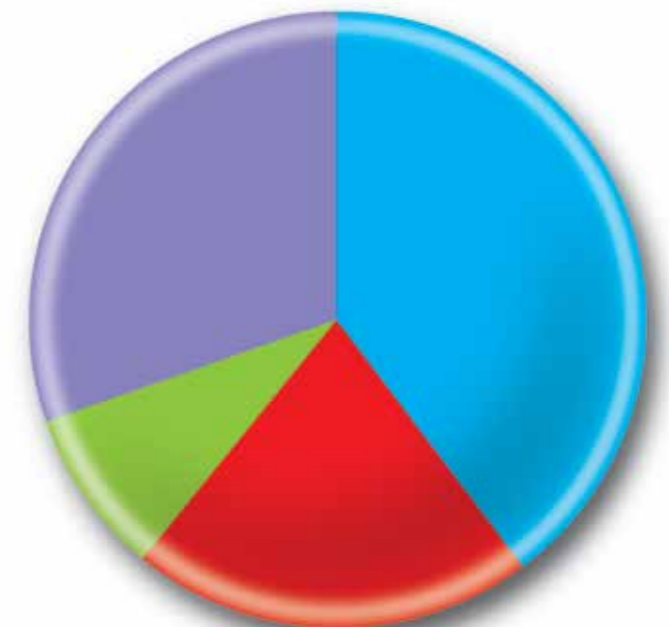
NON-COMPLIANCE BY TYPE OF DEFECT	TOTAL	AS %
Pilot ladder	278	43.23
Bulwark/Deck	127	19.75
Combination	52	8.55
Safety Equipment	186	30.59

Pilot Ladder ■
 Bulwark/Deck ■
 Combination ■
 Safety Equipment ■

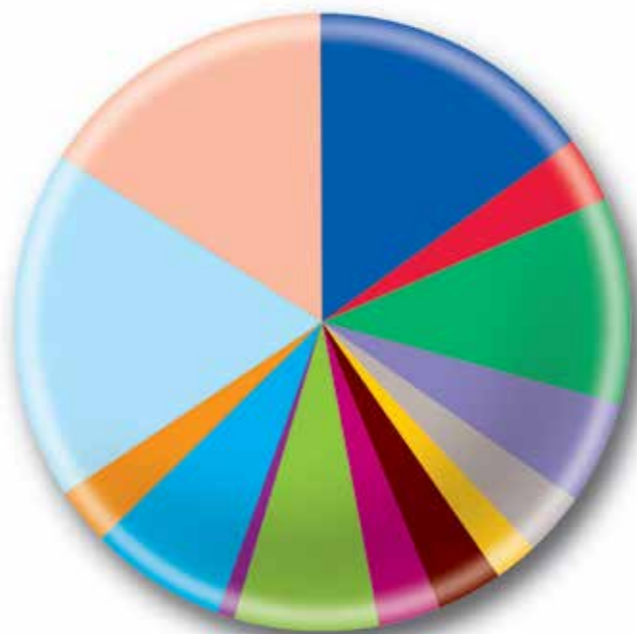
DEFECTS OF PILOT LADDER	TOTAL	AS %
Not against ship's hull	62	15.2
Steps not of suitable material	13	3.19
Poorly rigged retrieval line	44	10.78
Steps broken	23	5.64
Steps not equally spaced	13	3.19
Pilot Ladder more than 9 metres	9	2.21
Steps dirty/slippy	15	3.68
Sideropes not of suitable material	13	3.19
Pilot Ladder too far forward/Aft	31	7.6
Steps painted	3	0.74
Incorrect step fittings	30	7.35
No bulwark ladder	12	2.94
Steps not horizontal	75	18.38
Other	65	15.93

Not against ship's hull		Sideropes not of suitable material	
Steps not of suitable material		Pilot Ladder too far forward/Aft	
Poorly rigged retrieval line		Steps painted	
Steps broken		Incorrect step fittings	
Steps not equally spaced		No bulwark ladder	
Pilot Ladder more than 9 metres		Steps not horizontal	
Steps dirty/slippy		Other

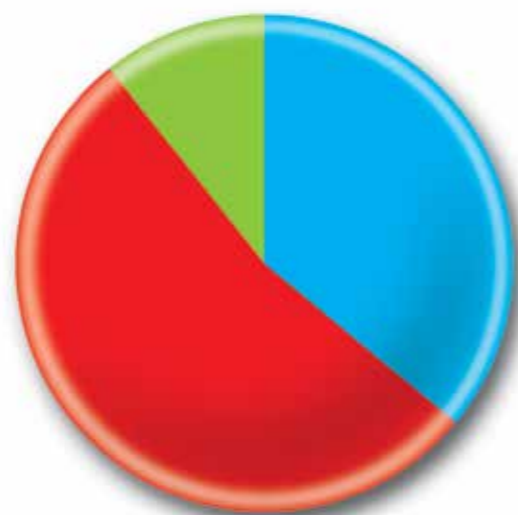
DEFECTS OF BULWARK / DECK

NON-COMPLIANCE BY TYPE OF DEFECT	TOTAL	AS %
No/faulty handhold stanchions	50	36.5
Ladder not secured properly	72	52.55
Other	15	10.95

No/faulty handhold stanchions	
Ladder not secured properly	
Other

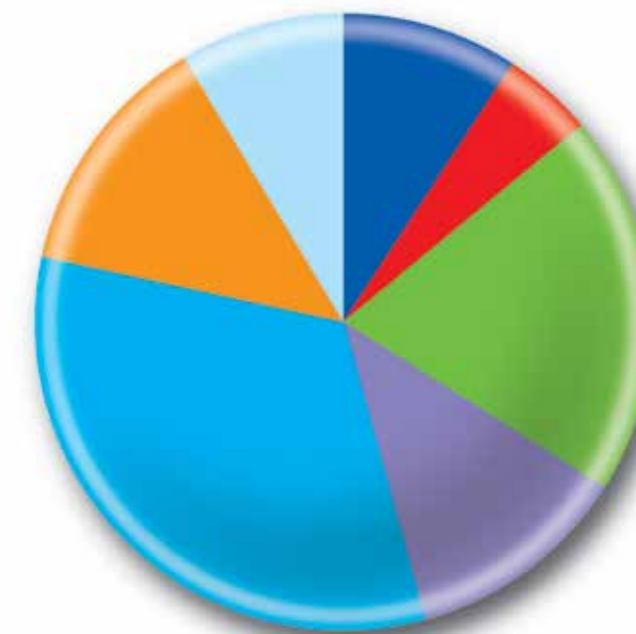
COMBINATION DEFECTS	TOTAL	AS %
Lower platform stanchions/rail incorrect rigged	12	9.3
Accommodation ladder too steep (>45 degrees)	6	4.65
Pilot ladder not attached 1.5m above accommodation ladder	26	20.16
Lower platform not horizontal	15	11.63
Ladder(s) not secured to ship's side	42	32.56
Lower platform less than 5 metres above the sea	17	13.18
Other	11	8.53

Lower platform stanchions / rail incorrect rigged		Ladder(s) not secured to ship's side	
Accommodation ladder too steep (>45 degrees)		Lower platform less than 5 metres above the sea	
Pilot Ladder not attached 1.5m above accommodation ladder		Other	
Lower platform not horizontal

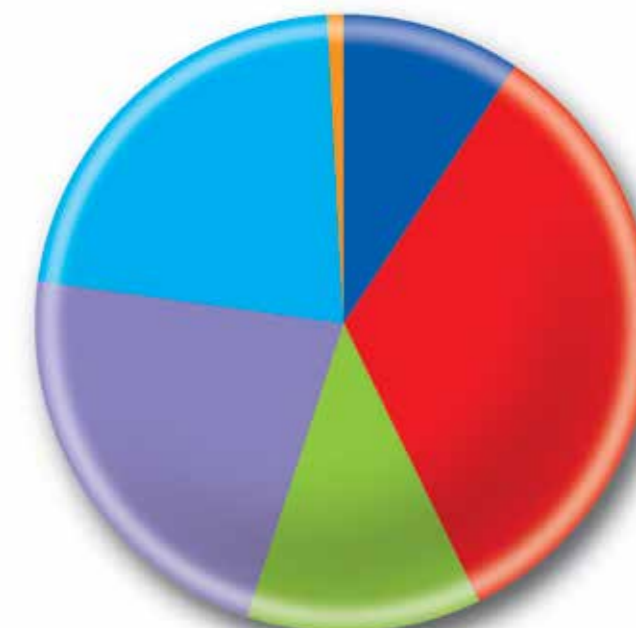
SAFETY EQUIPMENT DEFECTS	TOTAL	AS %
Inadequate lighting at night	31	9.72
No lifebuoy with self-igniting light	106	33.23
No VHF communication with the bridge	38	11.91
No heaving line	70	21.94
No responsible officer in attendance	72	22.57
Other	2	0.63

Inadequate lighting at night	
No lifebuoy with self-igniting light	
No VHF communication with the bridge	
No heaving line	
No responsible officer in attendance	
Other

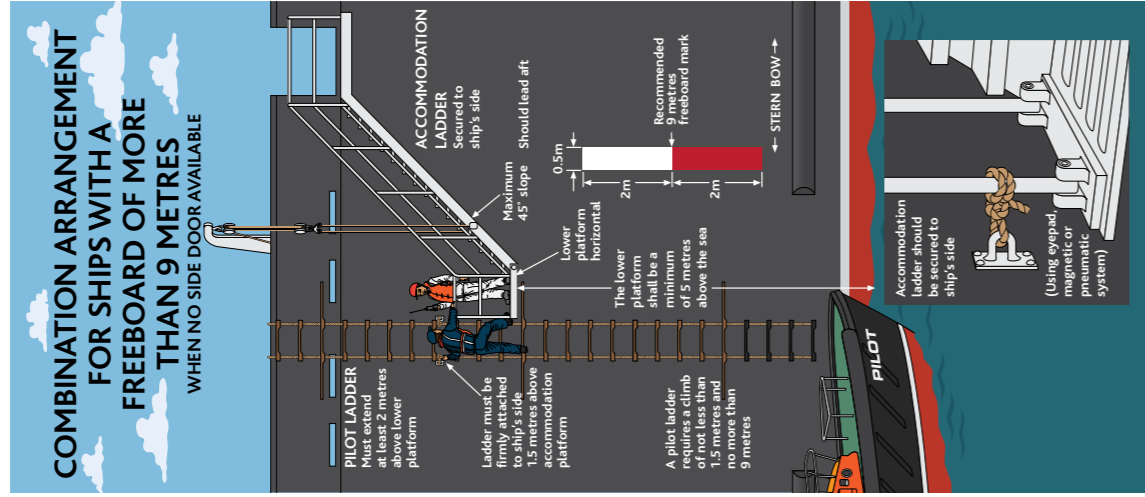
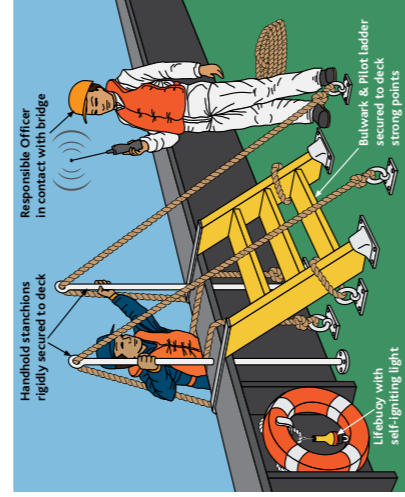
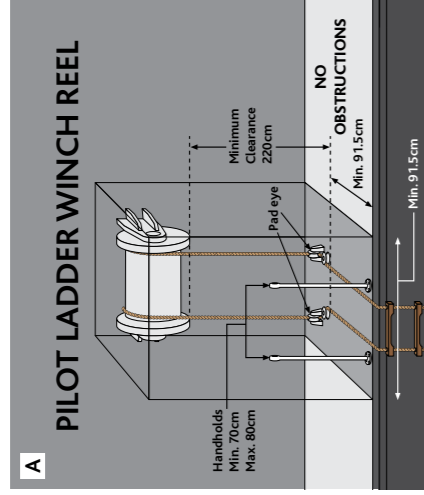
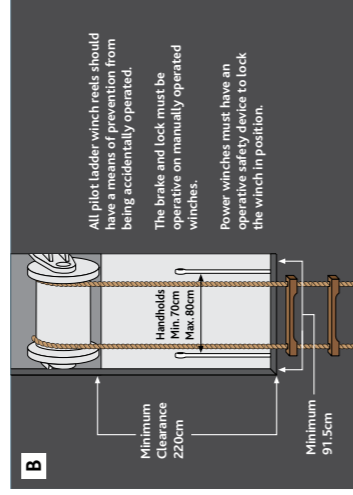
REQUIRED BOARDING ARRANGEMENTS FOR PILOT

In accordance with SOLAS Regulation V/23 & IMO Resolution A.1045(27)
