SAFETY CAMPAIGN

2021

IMPA Safety Survey 2021

The 2021 Annual IMPA Pilot Ladder Survey again highlights persistent non-compliance with SOLAS Regulations V/23 and associated supporting IMO Assembly Resolutions.

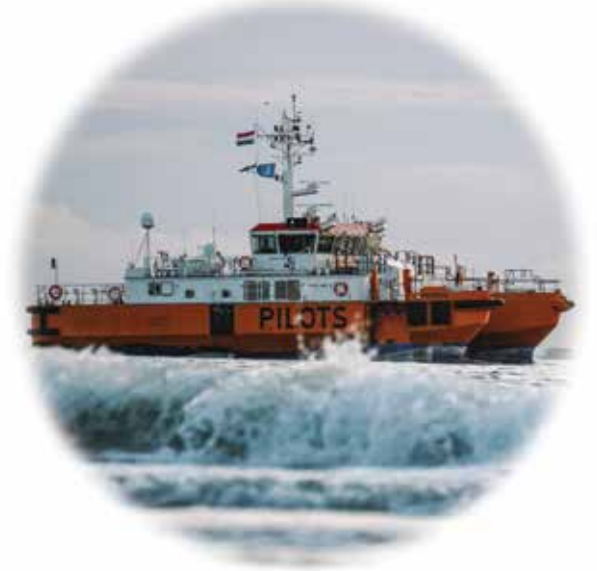
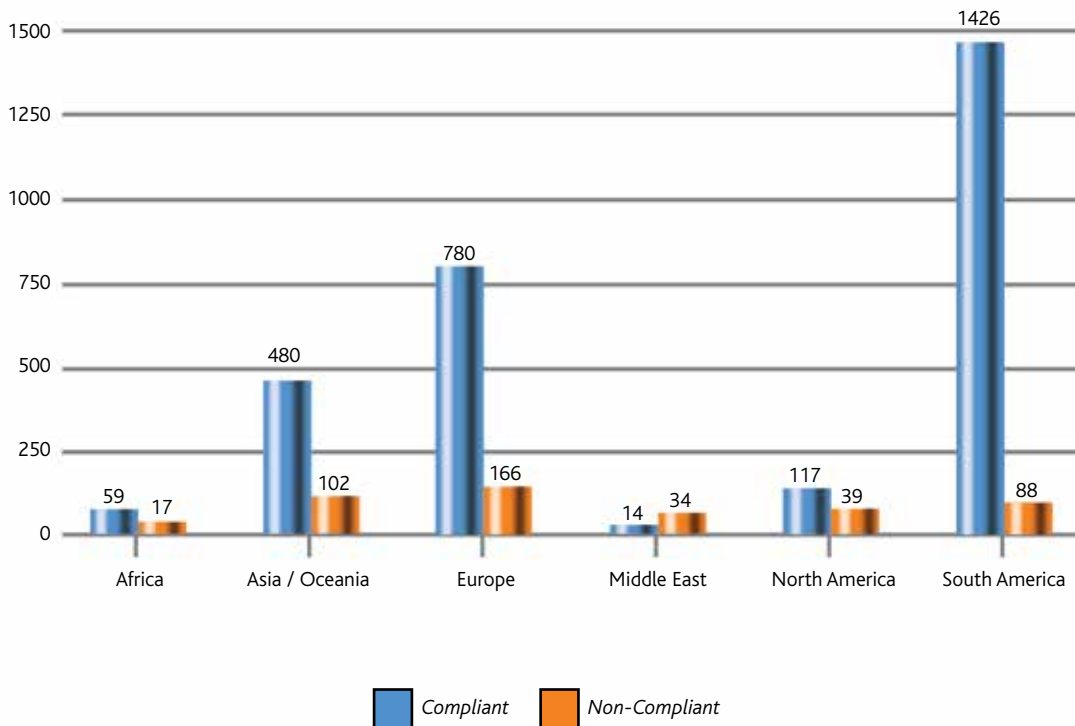
COMPLIANCE AND NON-COMPLIANCE BY REGION

The chart below shows 3,322 returns from participating IMPA members which have been grouped into 6 geographical areas.

COUNTRY	TOTAL RETURNS	COMPLIANT	NON COMPLIANT	NON COMPLIANT AS %
Africa	76	59	17	22.37
Asia / Oceania	582	480	102	17.53
Europe	946	780	166	17.55
Middle East	48	14	34	70.83
North America	156	117	39	25.00
South America	1514	1426	88	5.81
TOTAL	3322	2876	446	13.43

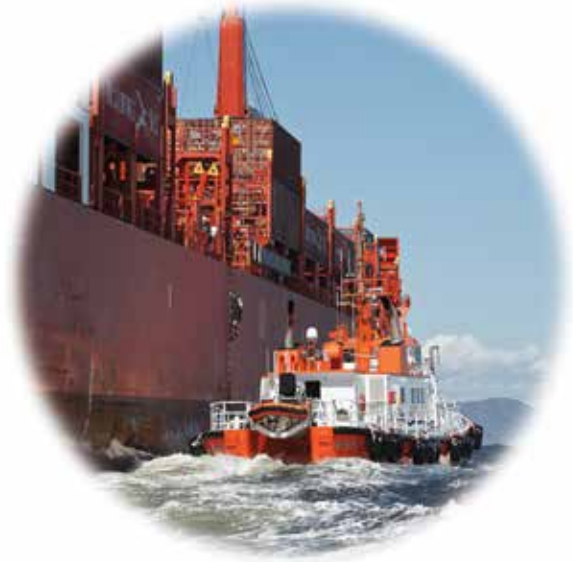
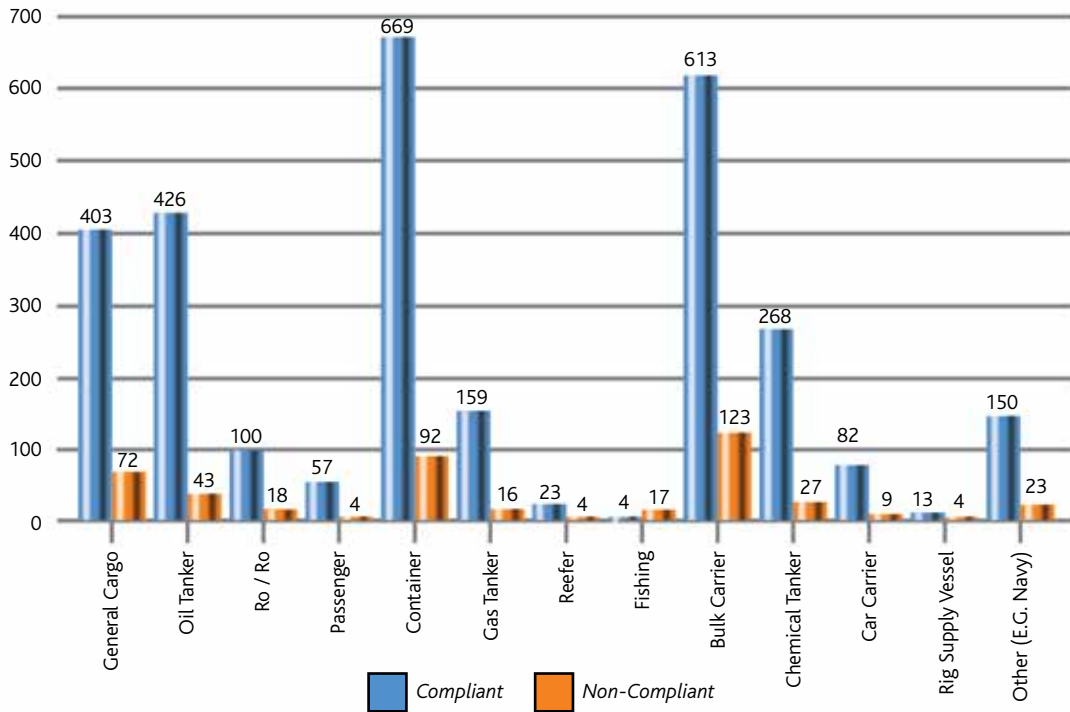
COMPLIANCE AND NON-COMPLIANCE BY VESSEL TYPE

The following chart shows a breakdown of all returns by vessel type.

VESSEL TYPE	TOTAL NUMBER OF VESSELS	COMPLIANT	NON COMPLIANT	NON COMPLIANT AS %
General Cargo	475	403	72	15.16
Oil Tanker	469	426	43	9.17
Ro/Ro	118	100	18	15.25
Passenger	61	57	4	6.56
Container	761	669	92	12.09
Gas Tanker	175	159	16	9.14
Reefer	27	23	4	14.81
Fishing	21	4	17	80.95
Bulkcarrier	736	613	123	16.71
Chemical Tanker	295	268	27	9.15
Car Carrier	91	82	9	9.89
Rig Supply Vessel	17	13	4	23.53
Other (E.G. Navy)	173	150	23	13.29

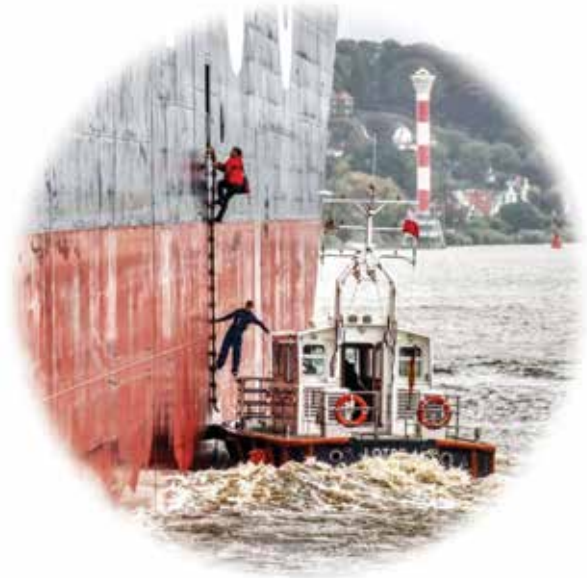
COMPLIANCE AND NON-COMPLIANCE BY MEANS OF TRANSFER

The following chart shows a breakdown of all returns by means of transfer.

MEANS OF TRANSFER	TOTAL NUMBER	COMPLIANT	NON COMPLIANT	NON COMPLIANT AS %
Pilot Ladder	2204	1910	294	13.34
Combination	795	676	119	14.97
Side Door and Pilot Ladder	232	201	31	13.36
Gangway	55	52	3	5.45
Helicopter	48	46	2	4.17
Deck to Deck	72	69	3	4.17

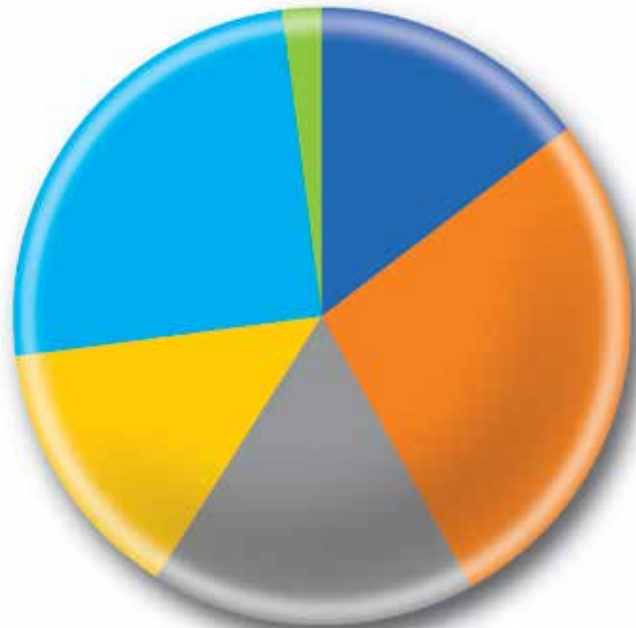
The first pie chart shows the combination defects. Both the number and percentage are shown. The second pie chart shows the safety equipment defects. Both the number and percentage are shown.

SAFETY EQUIPMENT DEFECTS	TOTAL	AS %
Inadequate lighting at night	22	14.47
No lifebuoy with self-igniting light	42	27.63
No VHF communication with the bridge	26	17.11
No heaving line	21	13.82
No responsible officer in attendance	38	25
Other	3	1.97
TOTAL	152
